# Halls Creek Environment Report Summary - 2015

Prepared for: Stockland

Prepared by: BMT WBM Pty Ltd and The Long View Group

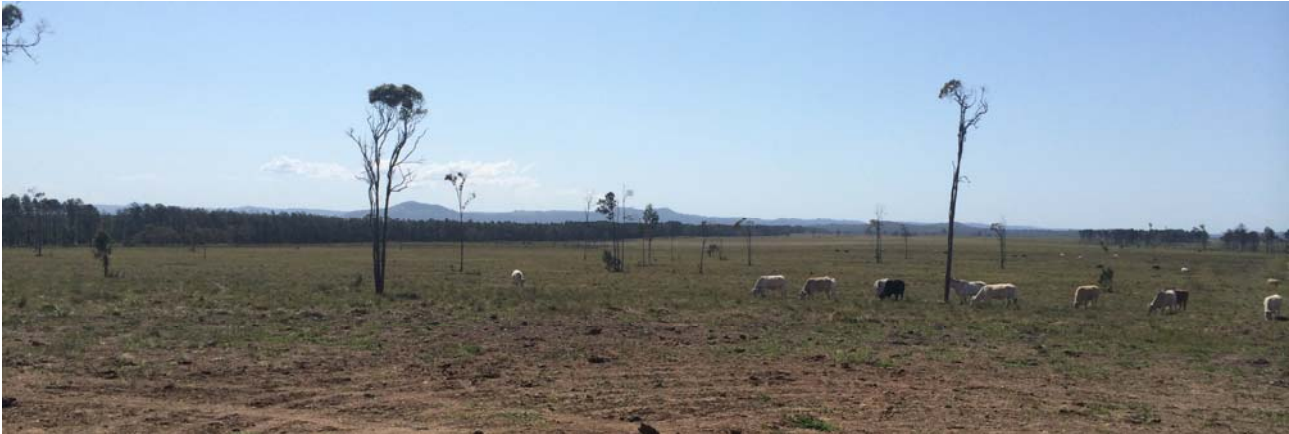
**Figure 2 Current land use and conditions at the Halls Creek site**

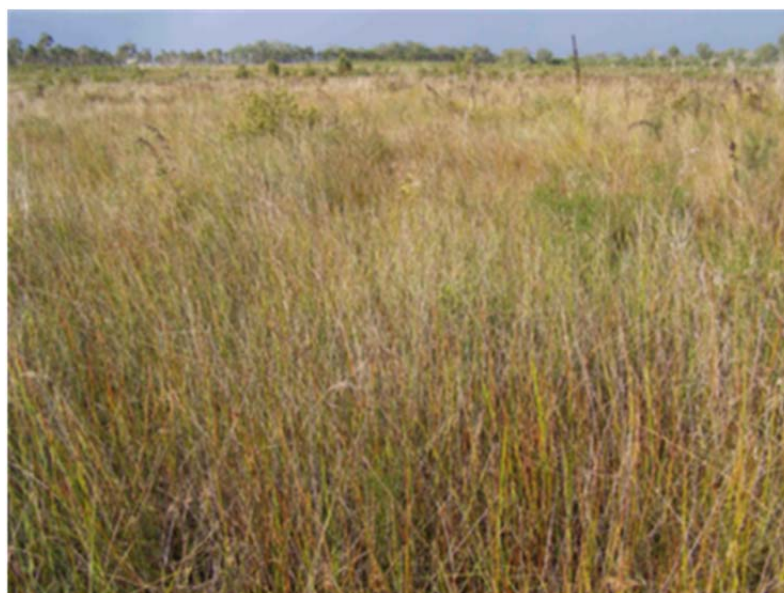
**Figure 6-1** Remnant wet heath/sedgeland in the north: known habitat for the Wallum Sedgefrog. July 2014

Large areas of the site during the Hyder survey (1999) were covered by exotic pine, a vegetation type which is unsuitable for Wallum Rocketfrogs and Wallum Sedgefrogs. With the clearing of this vegetation, transpiration will have reduced, allowing surface water to pool more frequently and persist for longer.

With the return of favourable habitat conditions, Wallum Rocketfrogs and Wallum Sedgefrogs are likely to have recolonised from pockets of native vegetation, and/or from nearby populations (such as those on Caloundra South). During favourable rainfall conditions (e.g., such as those experienced in 2012), current populations of these two species are likely to be at their highest since pre-clearing disturbance occurred.

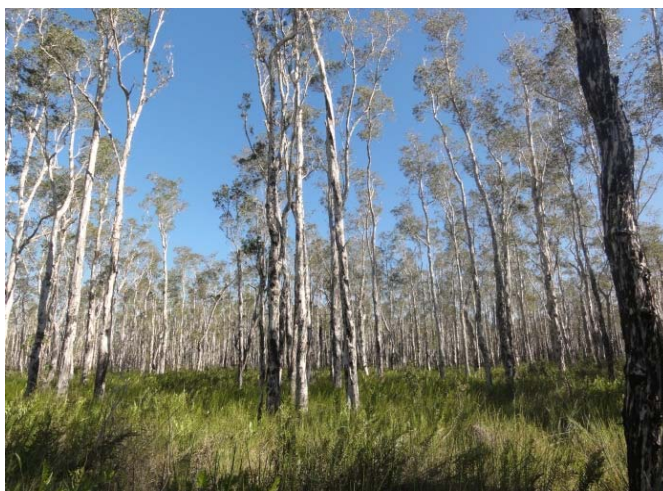
Figure 7-1 Paperbark wetland

The vast majority of the site is cleared. There are two patches of intact, remnant vegetation on the site. In the south-eastern corner of the site there is a 140ha patch of remnant Broad-leaved Melaleuca (Paperbark) open forest/woodland and wetland (RE 12.3.5), associated with the Halls Creek drainage depression. It is the only patch of regulated vegetation under the *Queensland Vegetation Management Act, 1999* (VM Act) on site.

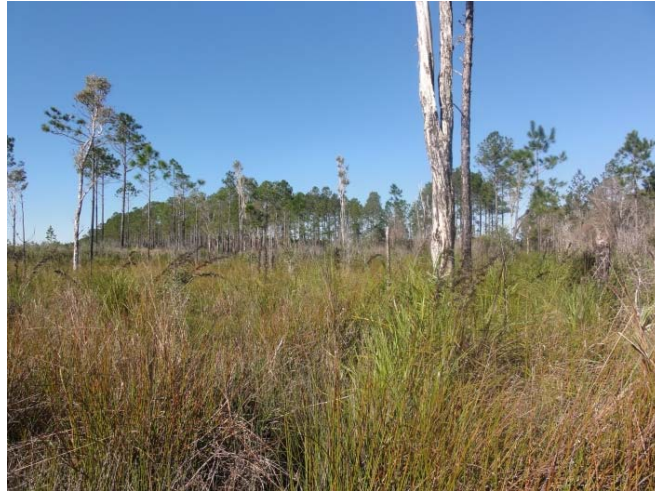
**Figure 7-3** Example of reedy regrowth along drainage line

was also observed along a drainage line near the centre of the site in late 2014. Further surveys will need to be undertaken in this area but it is likely that the habitat conditions at this location are less favourable than the remnant wet heathland areas in the north-western corner of the site.

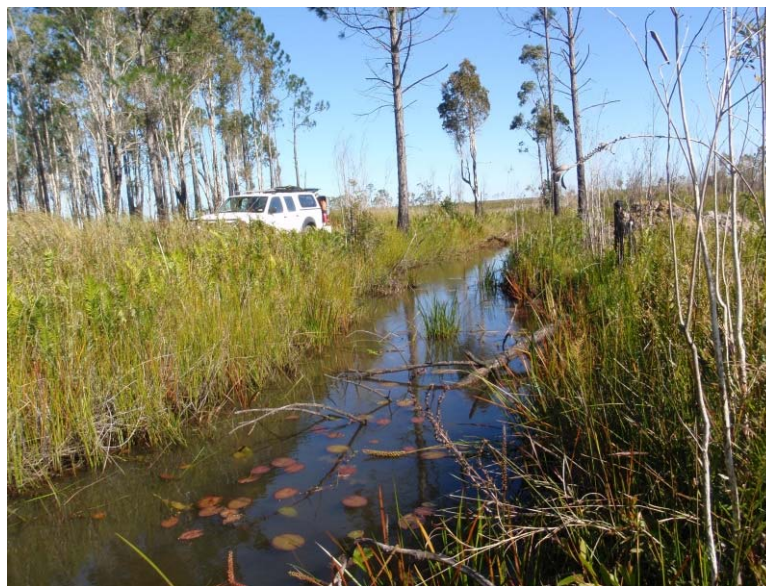
**Figure 8-1 Example of drainage channel – water is relatively clear, tannin-stained**

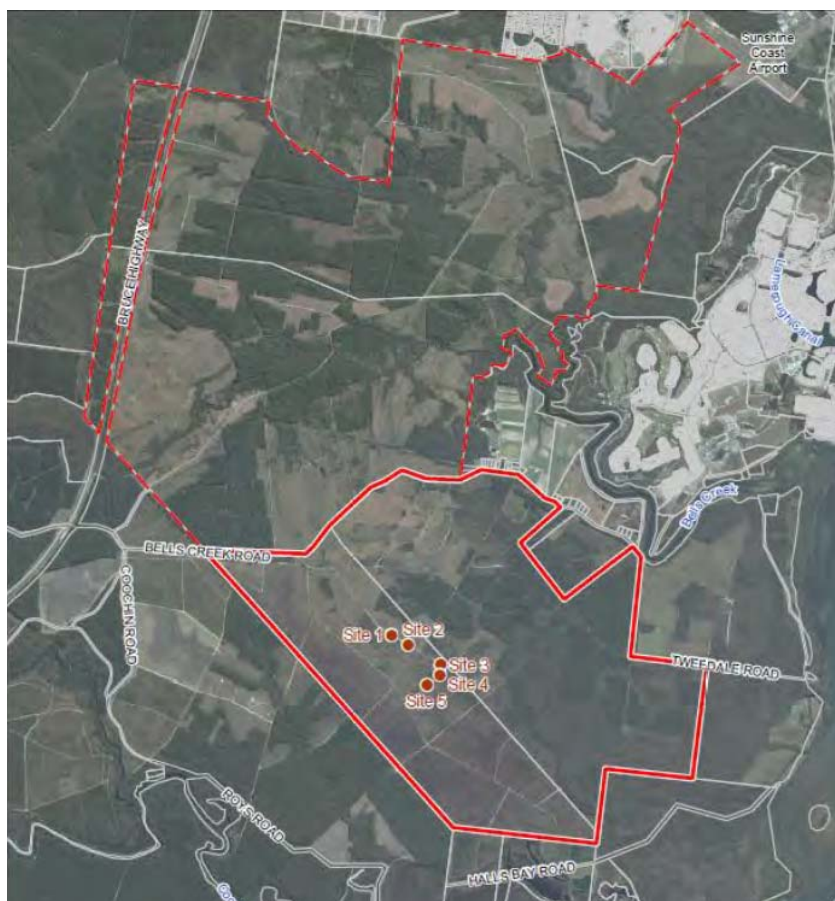
**Figure 9-1 Sites with archaeological remnants and debris on the site**

A Cultural Heritage Survey has been undertaken and a Cultural Heritage Management Plan (CHMP) developed in consultation with representatives of the Kabi Kabi people. The survey involved surface inspection of a number of transects identified by preliminary research. Archaeological remnants and debris were found in five sites within the Halls Creek Site.

The material appeared to be highly disturbed by previous site clearing and was removed from the site for preservation purposes. The materials found were indicative of transient, intermittent use of the land and no evidence was found of longer term or ceremonial occupation. Accordingly, the sites within the Halls Creek Site have been assessed to have low overall indigenous cultural heritage significance.
